## Test report

**Test report relating to a structural sealant according to ETAG 002 - Guideline for European technical approval for structural sealant glazing kits (SSGK) May 2012 - concerning the product marked as: MF881-25 Silicone structural sealant, manufactured by: Zhengzhou Zhongyuan Silande High Technology Co. Ltd**

| Report number | 89212213-01 REV01 |
| Project name | 17.A196 - ETAG 002 |

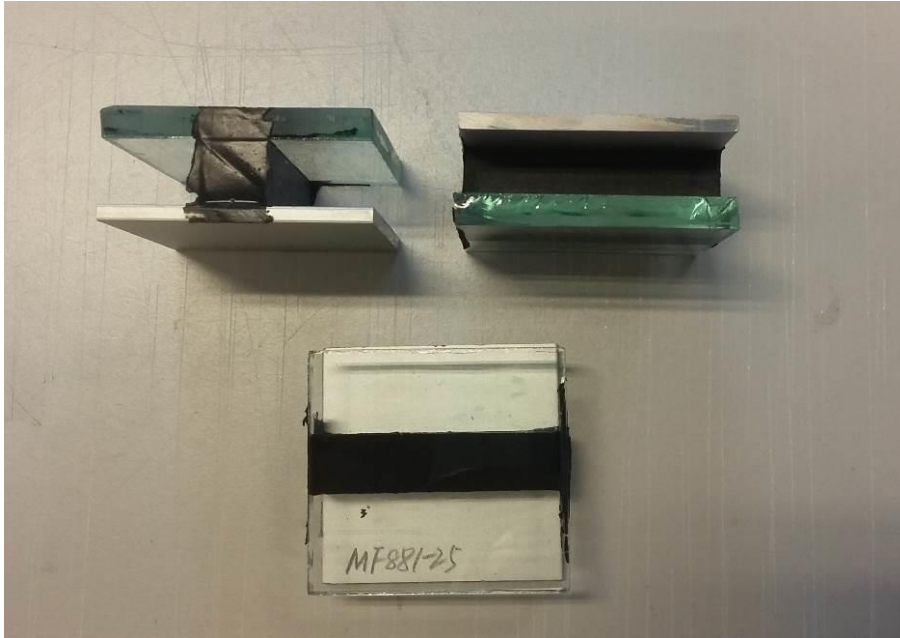
Sample type 1 (H-sample) 6 mm float glass. 3 mm anodised aluminium. seal joint 12x12x50 mm

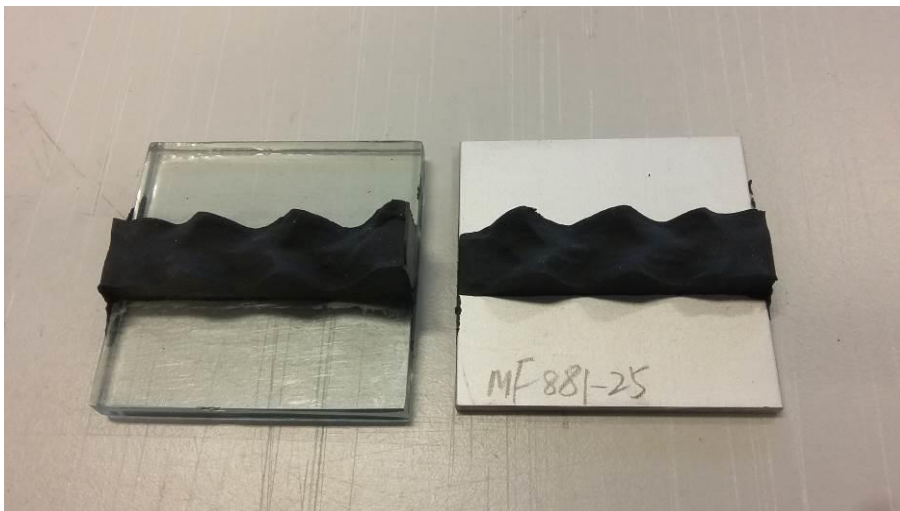
Sample type 1 (H-sample) typical failure pattern

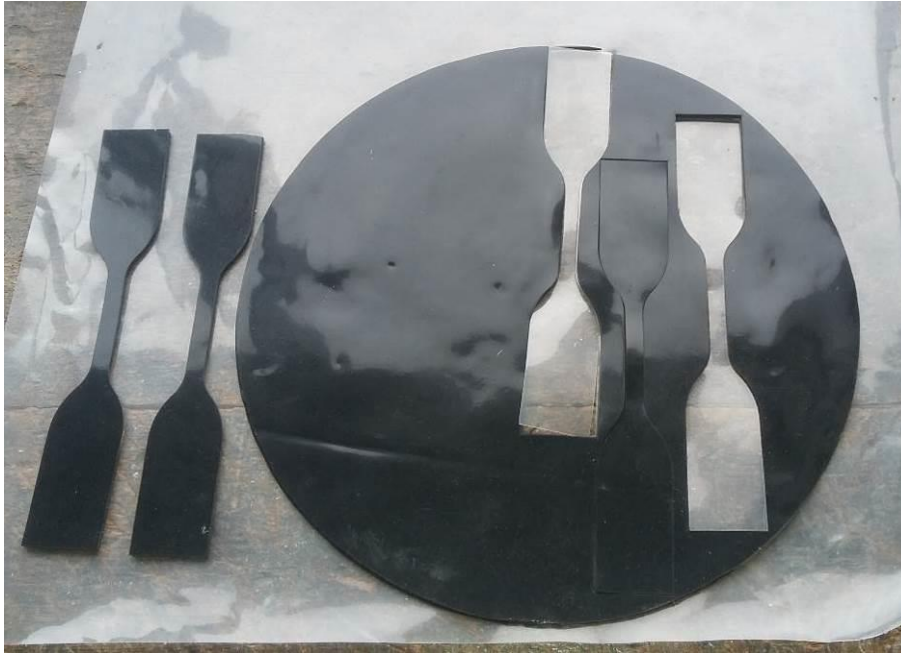
Sample type 2 and ISO 527 type 5 specimens punched from 2 mm sealant film

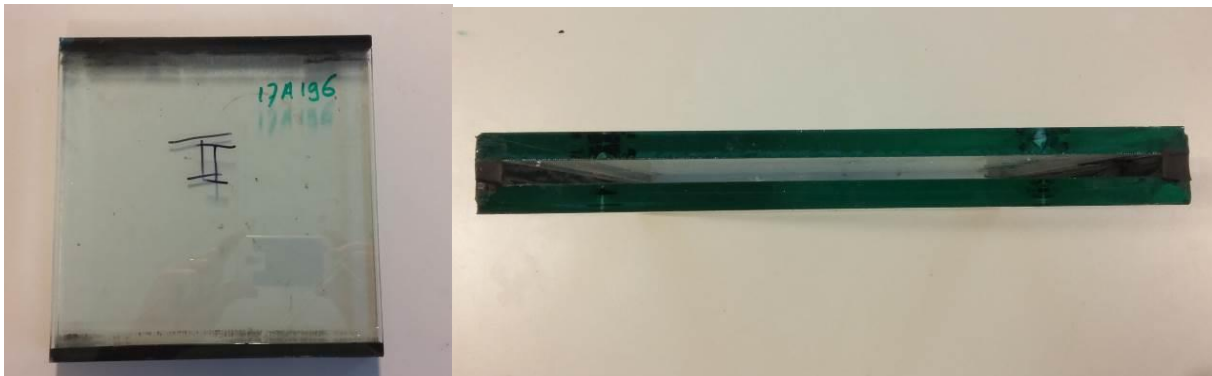
Sample type 3. creep behaviour

$h = 7.8 - 8.0 \text{ mm}$   
 $e = 6 \text{ mm}$   
 $L = 200 \text{ mm}$
